# WOKINGHAM BOROUGH COUNCIL FLOOD INVESTIGATION REPORTS

WINTER 2013/2014

JANUARY 2016

**WSP | Parsons Brinckerhoff**

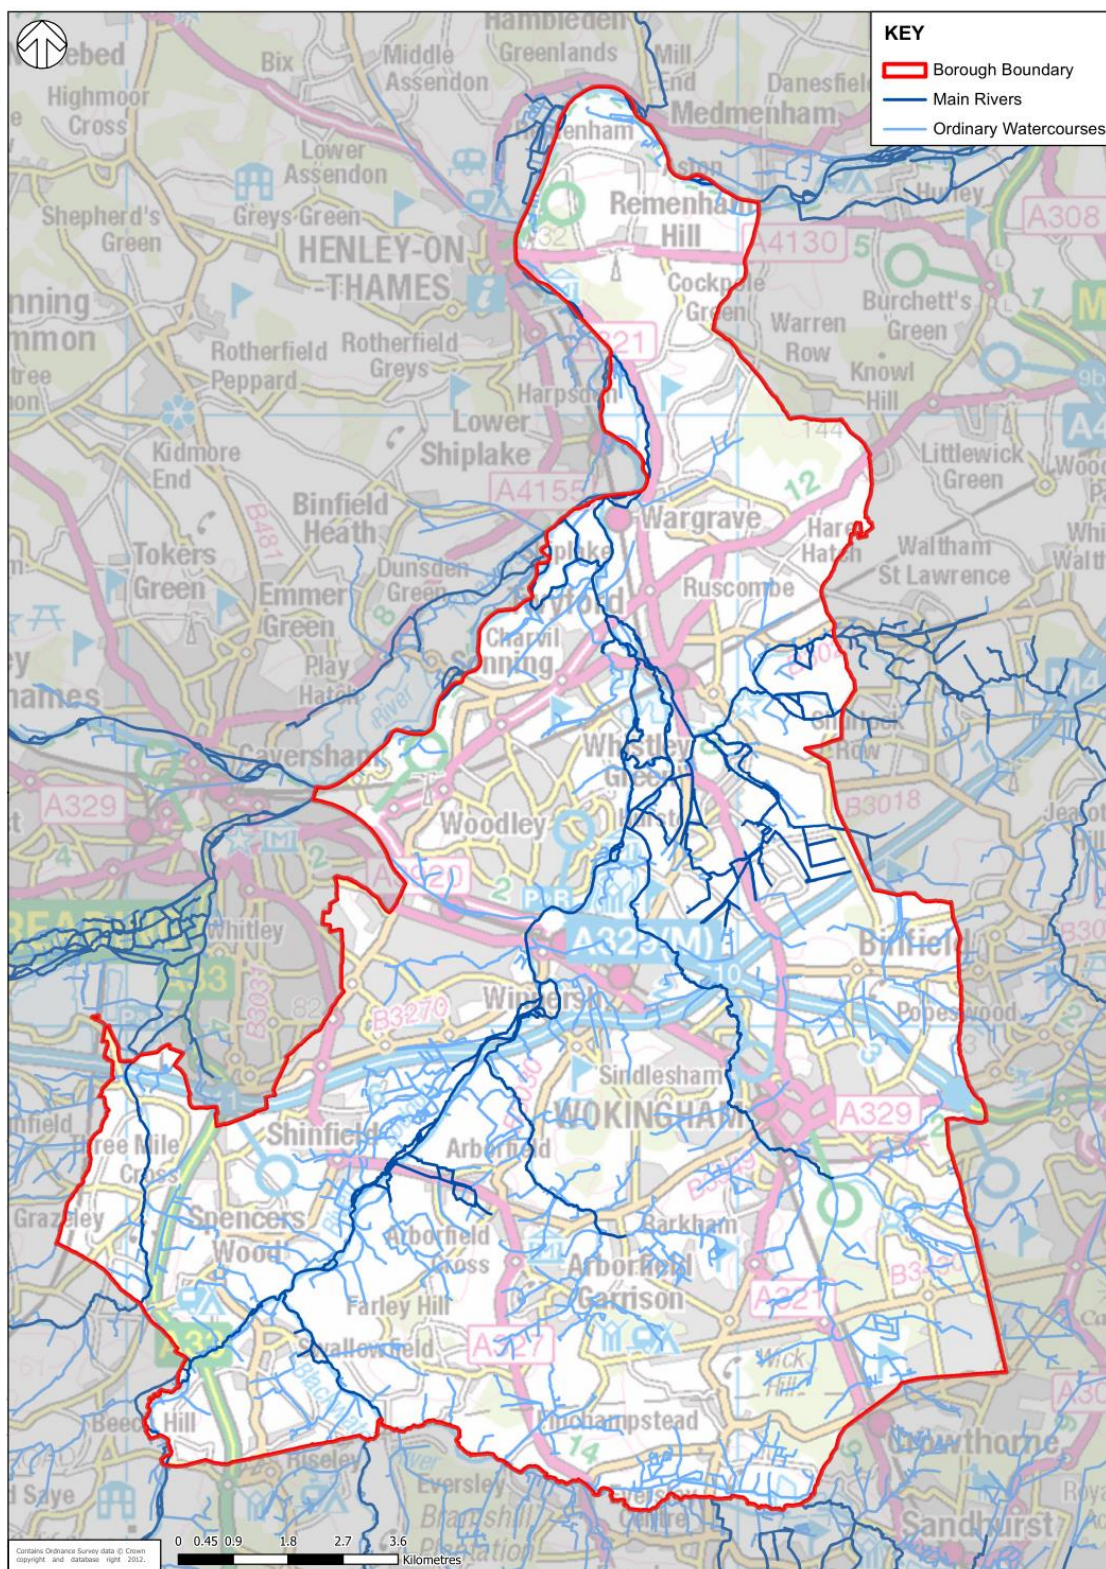
Figure 1-1 Figure 70007120/1/101: Wokingham Borough Main River and Ordinary Watercourse Network

- 1.1.5 The worst affected areas were those located close to the major rivers in the borough; the River Loddon, the River Thames and the River Blackwater. The river and groundwater levels in the catchments were high throughout the period. The repeated storms generated maximum levels on these rivers and other tributaries of the River Thames in Wokingham. This resulted in even more water being added to an already inundated Thames floodplain. The location of these rivers is illustrated in figure 70007120/1/101.

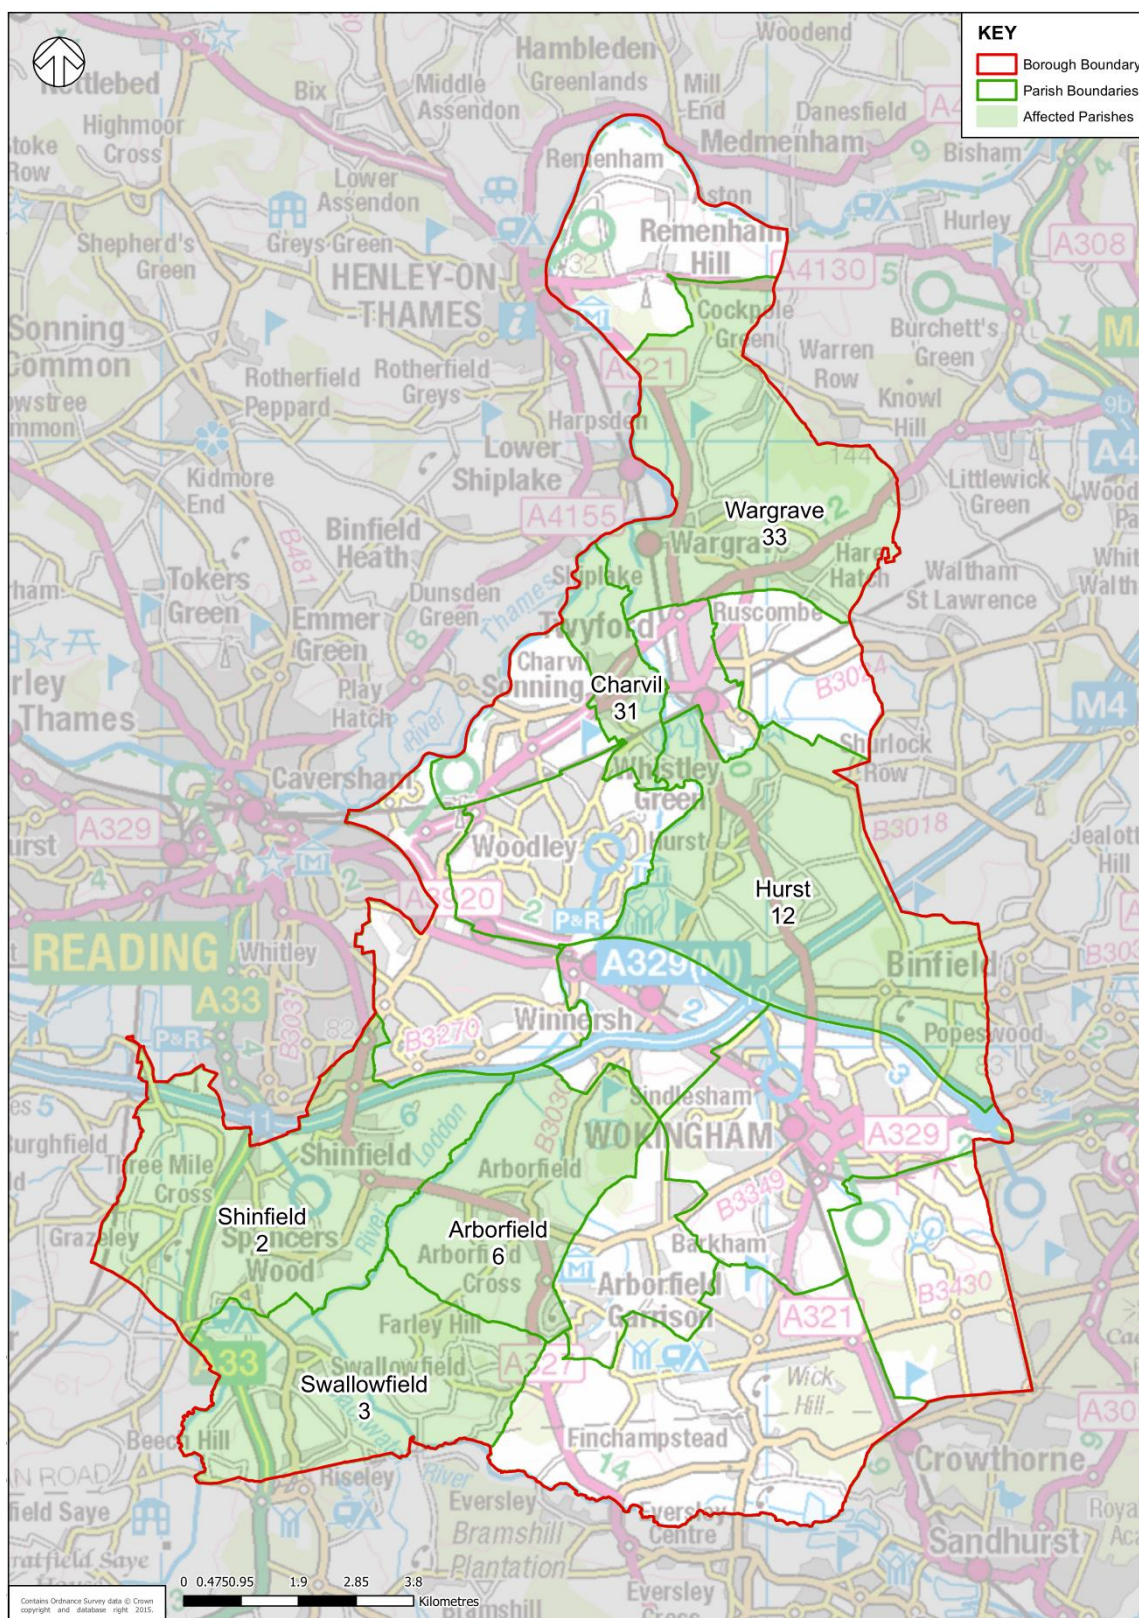
Figure 1-2 Figure 70007120/1/102: Total Number of Internally Flooded Properties by Parish

- 1.1.6 Figure 70007120/1/102 illustrates the areas affected by flooding during the winter 2013/14 flood event based on the total number of properties that suffered internal and/or external flooding across Wokingham.
