## CALIFORNIA CROSSROADS

Stage 4 Road Safety Audit

**REPORT NUMBER: UK0045909.0032/RSA4/1/0**

**DATE: JUNE 2026**

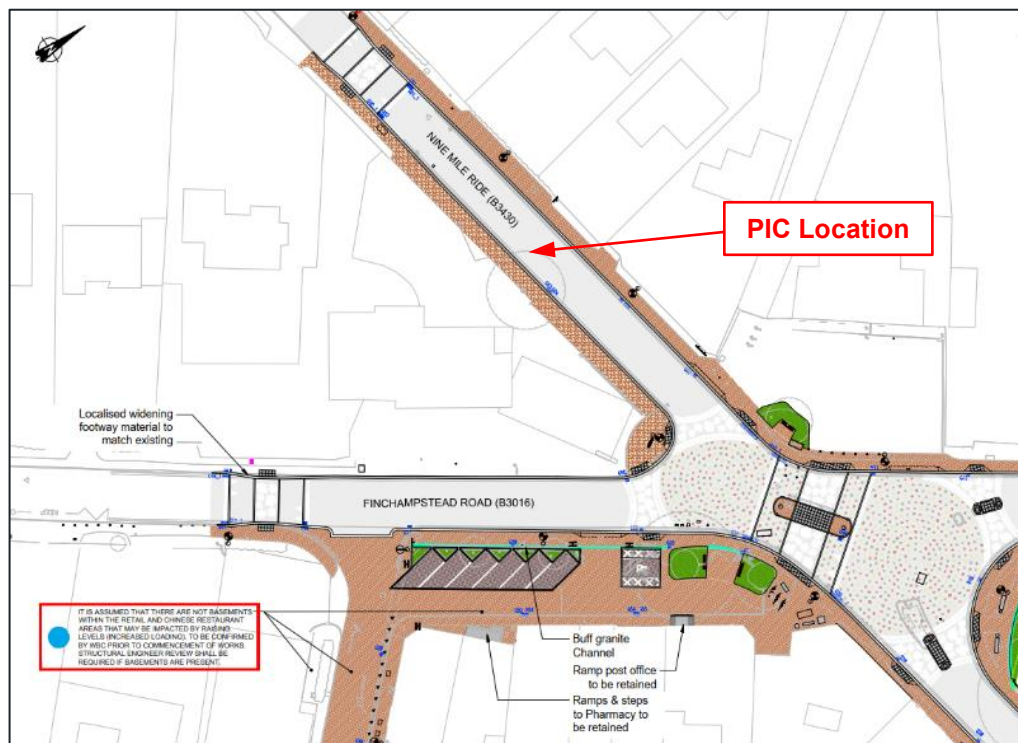
Figure 1 – Collision Location Plan

- 2.2.1. The PIC recorded during the 12-month 'post-construction' period was slight in severity and involved a car travelling westbound on Nine Mile Ride colliding with a pedestrian who was crossing the carriageway. This collision took place approximately 30m to the west of the California Crossroads junction, as shown on Figure 1 above.
- 2.2.2. It should be noted that the contributory factor information for this collision indicates the following (in relation to the driver of the motor vehicle):
- Driver was affected by alcohol;
  - Driver was being aggressive, dangerous or reckless; and
  - Ineffective observation by the driver.

2.2.4. In addition, the PIC data indicates that this collision took place during daylight conditions, when the weather was 'fine' and the road surface was dry, so these road environment factors are very unlikely to have been a contributing factor.

2.5.2. This PIC appears to have been caused as a result of driver negligence / error – i.e. the driver was impaired by alcohol and was being aggressive, dangerous or reckless, according to the contributory factor information for this collision. Therefore, it is considered by the Stage 4 Road Safety Audit Team that the highway layout in this location is very unlikely to have contributed to this collision taking place.

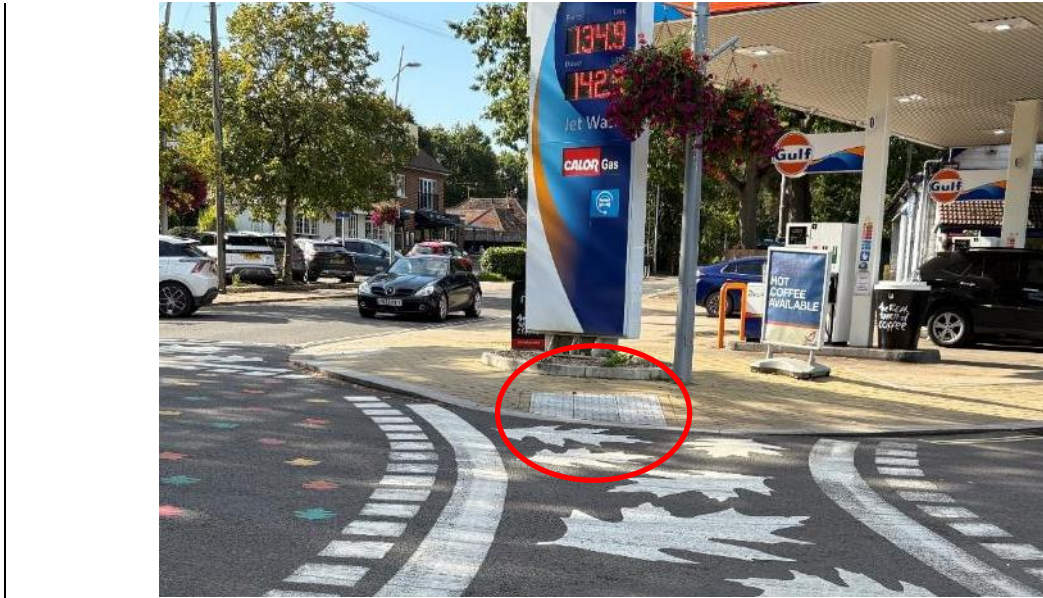
*As shown on the following photograph, it was observed that the petrol station fuel price totem restricts the visibility from the new pedestrian crossing point on the south side of the western Nine Mile Ride junction approach (i.e. obstructing the visibility of vehicles that are about to turn left from Finchampstead Road onto Nine Mile Ride).*

*It is unclear from the comments by the Design Team and the Overseeing Organisation whether they have consulted with the petrol station's owner to see whether the 'totem' can be moved to an alternative appropriate location where it will not obstruct the visibility to / from any pedestrian crossing points.*

*Therefore, this problem and the recommendation made by the Stage 3 Road Safety Audit Team is considered to be unresolved.*

*Therefore, it is still recommended that the local highway authority consults with the petrol station owner to determine whether the petrol station sign can be relocated to a position where it will not restrict the visibility from the adjacent pedestrian crossing point (if this has not been done already).*

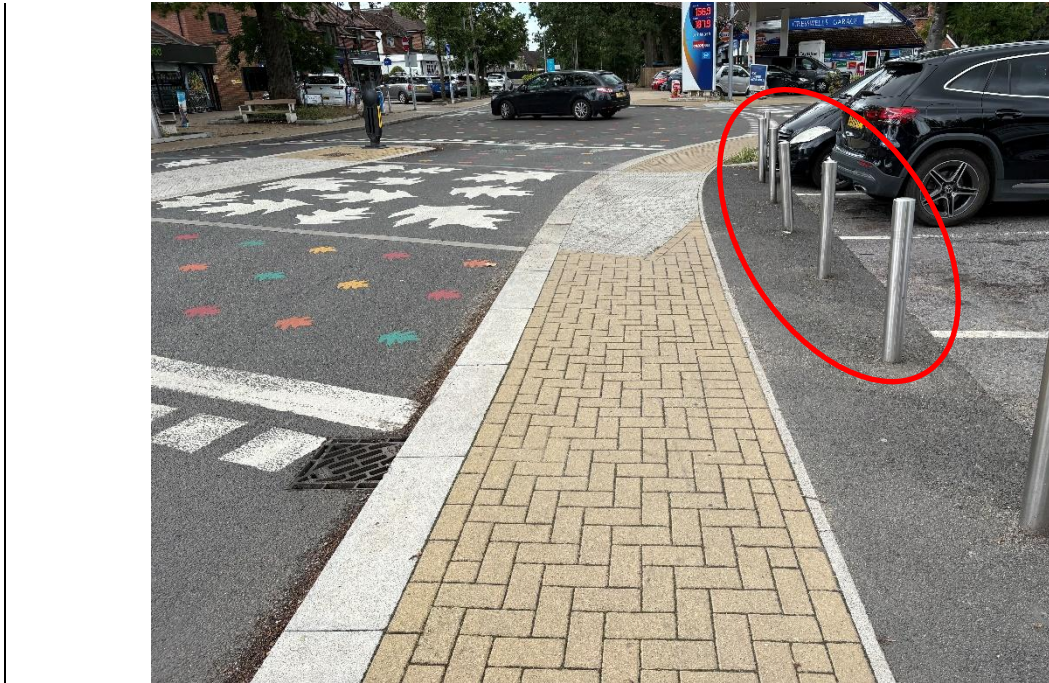
*During the site visit, the Stage 4 Road Safety Audit Team observed that the bollards installed adjacent to the parking bays at the Red Oak Stores parking area have not been provided with reflective banding, and that some of these bollards appear to have been struck by vehicles using the adjacent parking bays (as circled in red on the following photograph).*

*Therefore, it is recommended that appropriate reflective bands are installed on the bollards in this location.*

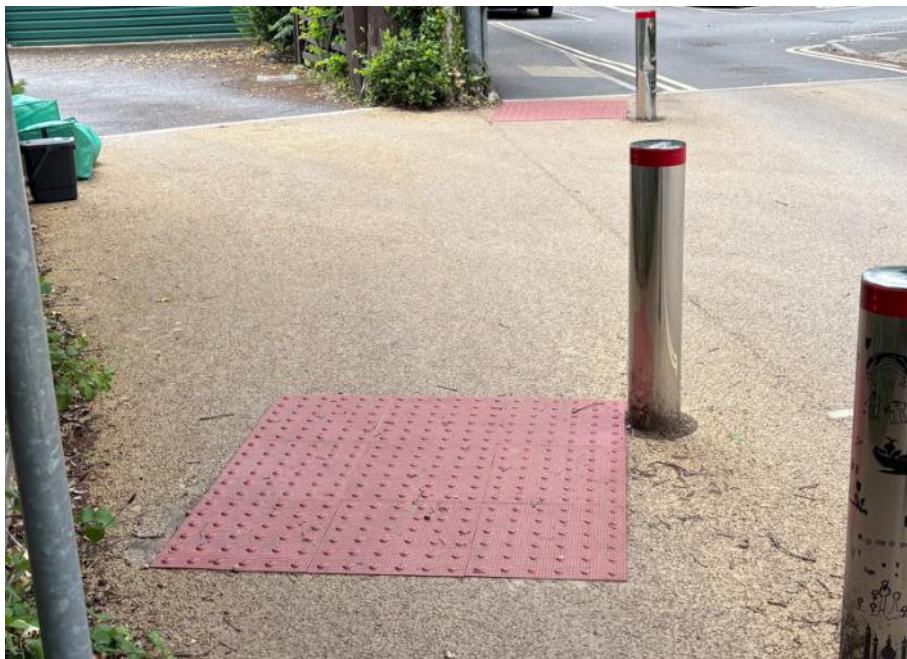
*At uncontrolled crossings, the blister surface is usually buff, but any colour (other than red) can be used so long as it achieves effective colour or tone contrast with the surroundings."*

Therefore, it is recommended that the tactile paving in this location is replaced, so that it has an alternative colour which is contrasting to the adjacent carriageway surfacing.

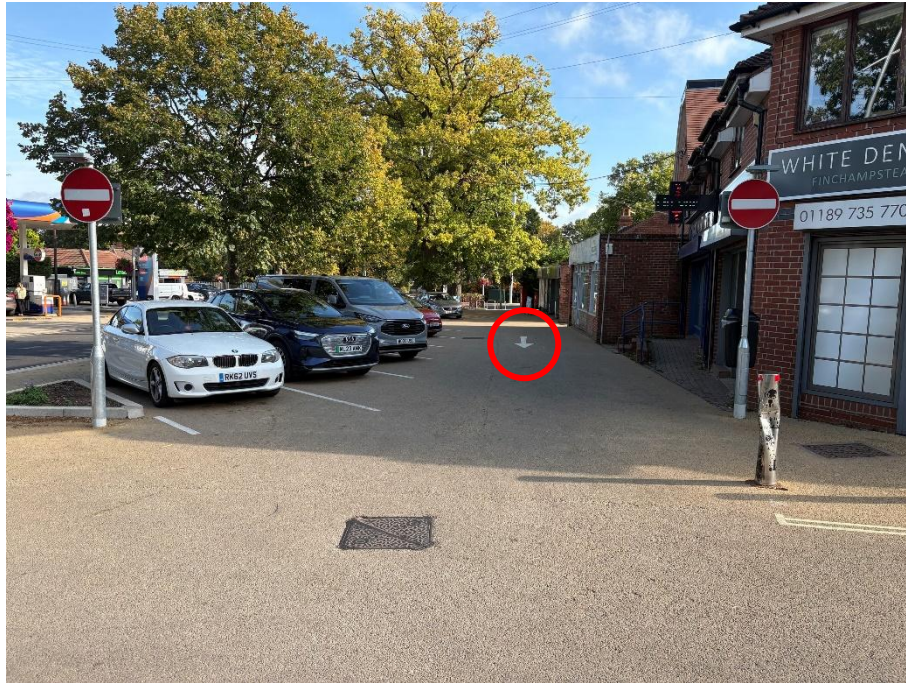
It was observed during the site visit that ahead arrow road markings have been installed at the entrance into the car park and in the centre of the car park area. However, as shown on the photograph below, the arrow road marking in the centre of the car park is located some distance away from the 'No Entry' traffic signs at the exit from the car park.

This could increase the possibility of a driver mistakenly turning into the wrong end of the car park area, then seeing the arrow road marking in the centre of the car park, and then reverse out of the car park where they could come into conflict with other road users. Therefore, it is recommended that an additional ahead arrow road marking is provided adjacent to the 'No Entry' traffic signs at the exit from the car park.

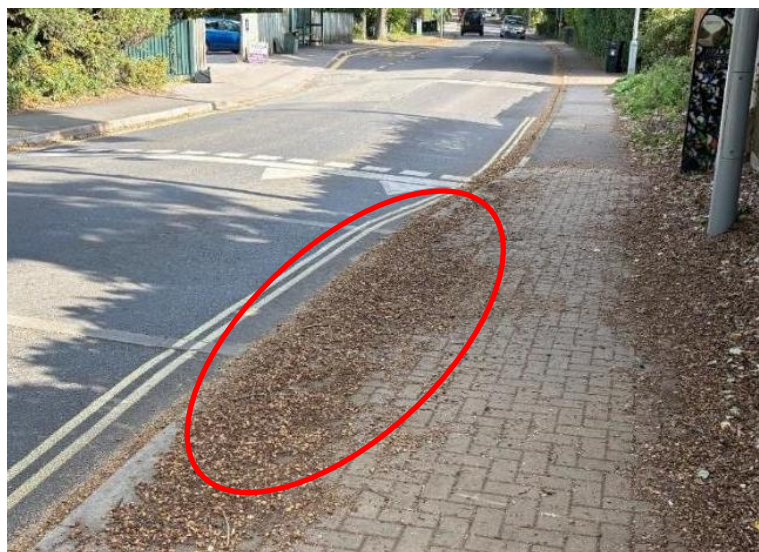
It was observed during the site visit that detritus (such as leaves and acorns falling from the adjacent trees) had collected at the following pedestrian crossing points:

- The pedestrian crossing point on the north-west side of Finchampstead Road at the raised crossing facility adjacent to the junction with the Avery Corner Car Park access road.
- The pedestrian crossing points at the raised crossing facility on Nine Mile Ride to the east of the junction with the Avery Close.
- The pedestrian crossing point on the south-east side of Finchampstead Road at the raised crossing facility located approximately 40m to the north-east of California Crossroads (as shown on the photograph below).

This could reduce the conspicuity of the tactile paving at the pedestrian crossing points for visually impaired pedestrians, or impact on a partially sighted user's ability to detect the raised blisters, which could increase the possibility of one of these users not crossing directly between the pedestrian crossing points and possibly tripping over the adjacent full height kerbs or transition kerbs.

*It is recommended that the whole area of the scheme is swept to remove the detritus as soon as possible. Because of the extensive vegetation in the vicinity of the scheme (including large deciduous trees), the highway authority should establish an appropriate programme of road / footway sweeping.*

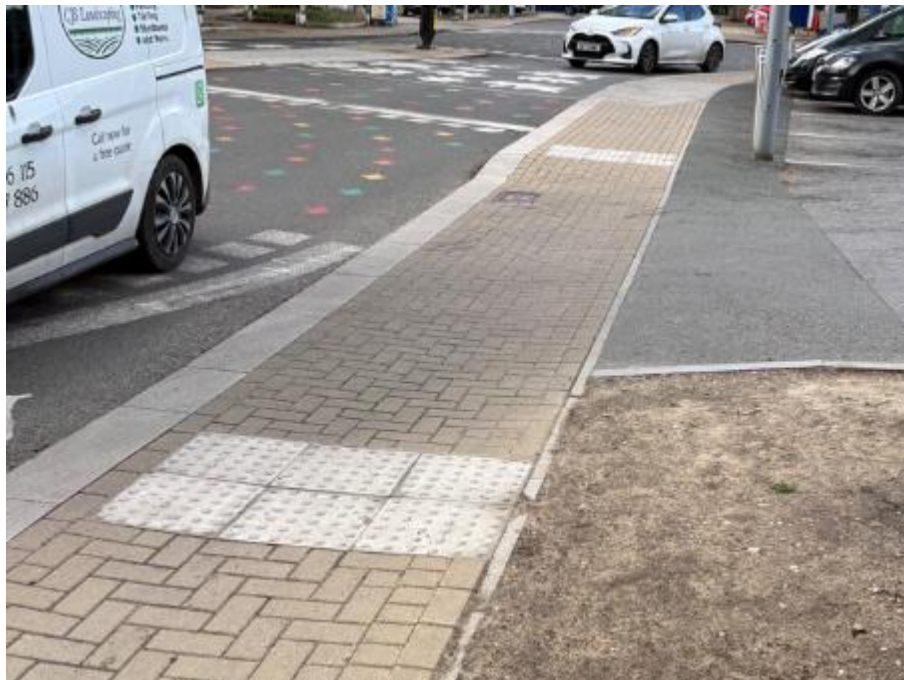
As shown on the photograph below, it was observed during the site visit that blister tactile paving has been installed on both sides of the Red Oak Stores eastern car park access. However, similar tactile paving has not been installed at the western access for this car park. Therefore, for consistency, it is recommended that the Overseeing Organisation considers if appropriate tactile paving should be installed on both sides of the western car park access.

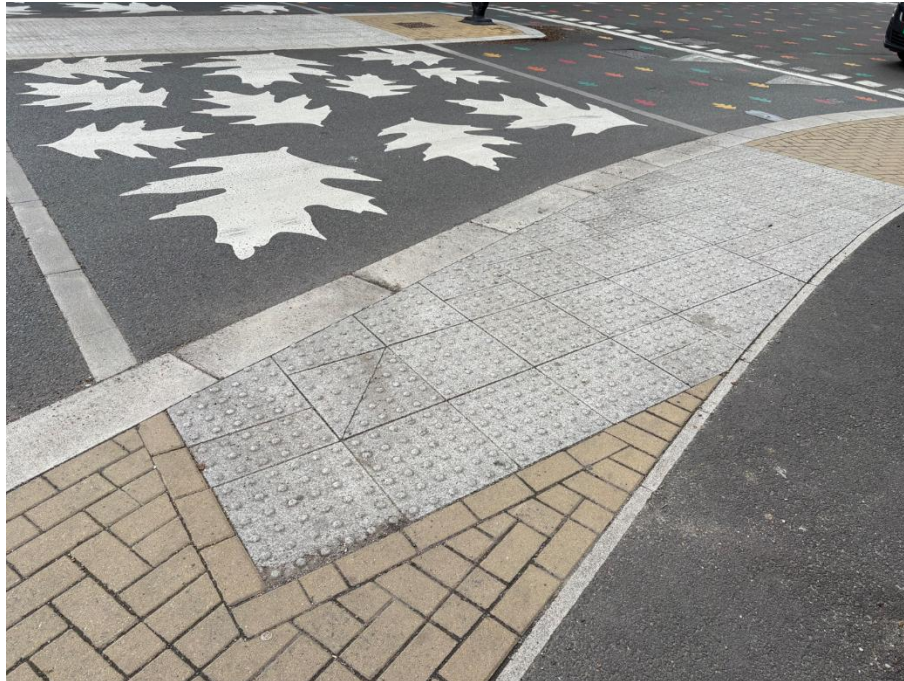
The GDFTBA representative's comments above are noted (the following photograph shows the layout of the tactile paving provided in this location). The Stage 4 Road Safety Audit Team do not have any specific comments in relation to the layout and condition of this area of tactile paving and the paving provided appears to be appropriate and do not raise a material road safety concern in the context of this Stage 4 Road Safety Audit. The Stage 4 Road Safety Audit process is an evidence-led review of road traffic collisions that have occurred in the vicinity of the highway scheme, it is noted that no PICs have occurred at this pedestrian crossing facility since the highway scheme was implemented.

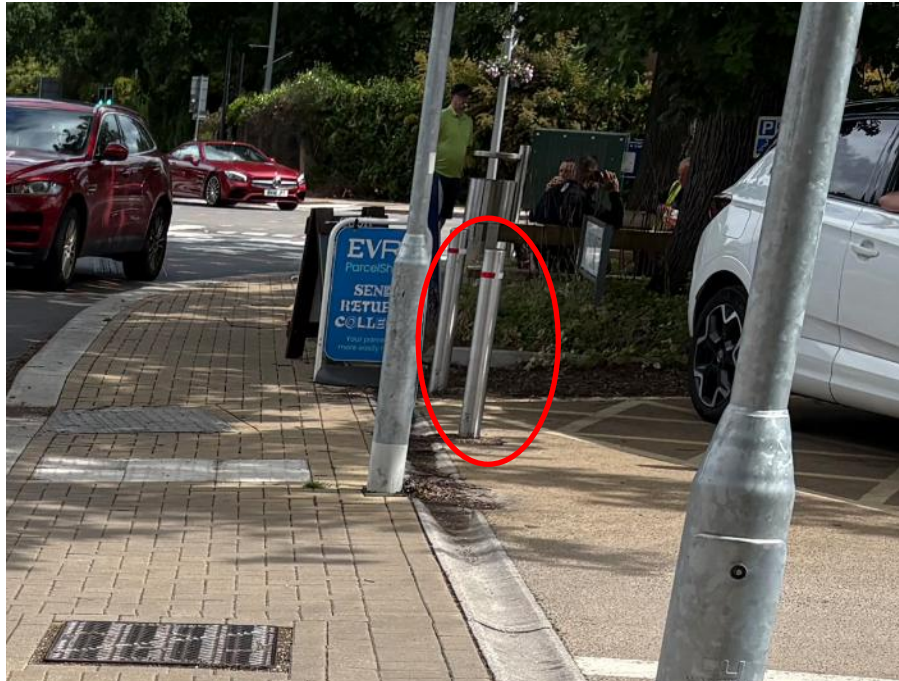
It was observed during the site visit that a new bollard has been installed to mitigate the possibility of a vehicle travelling over the tactile paving to access the disabled parking bay, as circled in red on the photograph below.
