# Wokingham Section 19 Flood Investigation

## Final Report

November 2024

**WOKINGHAM  
BOROUGH COUNCIL**

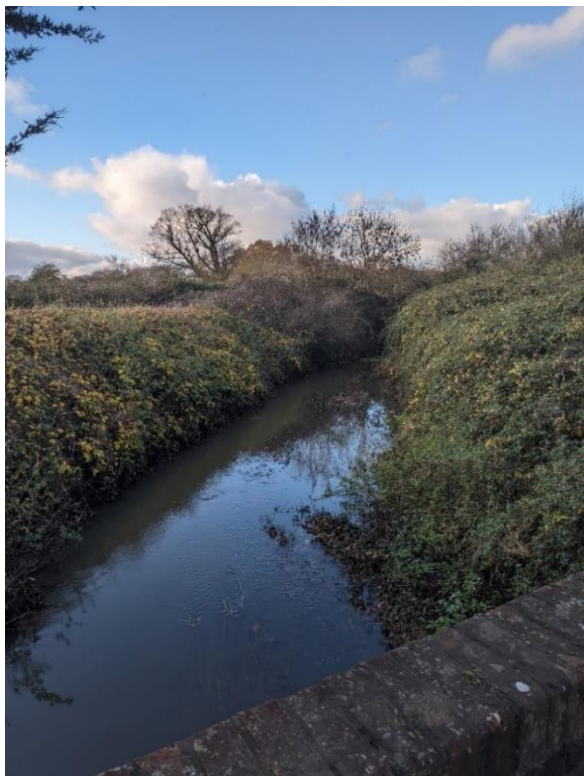
Figure 4-3: Photographs of the Twyford Brook, a Main River in Hurst Parish and Twyford

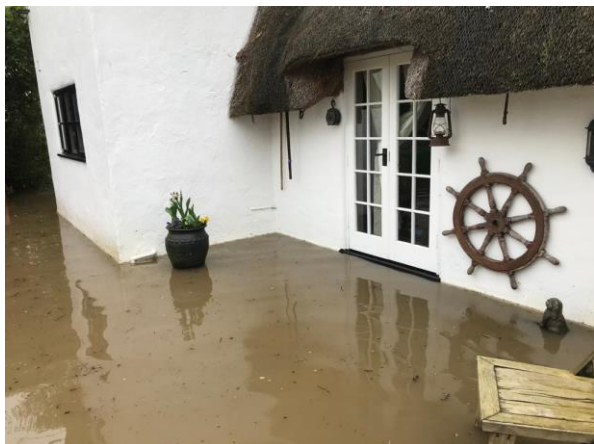
1. Flood water encroaching onto owner's land, up to front of property.

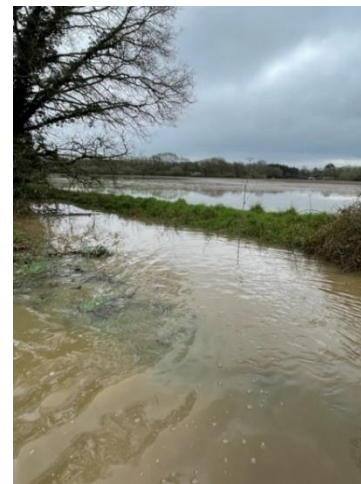
2. Flooding of ditch and field adjacent to Hogmoor Lane

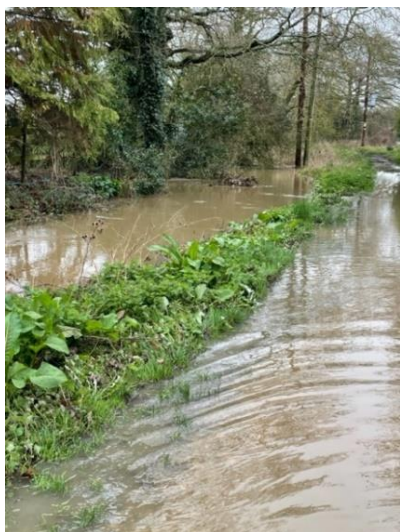
3. Flooding of Hogmoor Lane and adjacent ditch

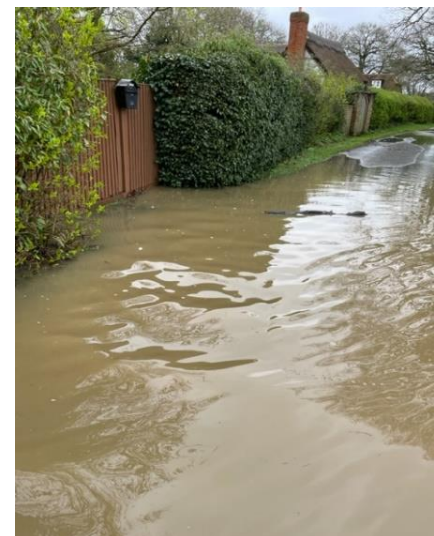
4. Surface water pooling outside property

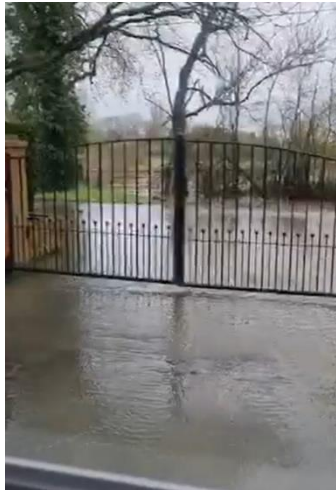
1. Flooding of Wokingham Road and Front drive of property on 31 March 2023

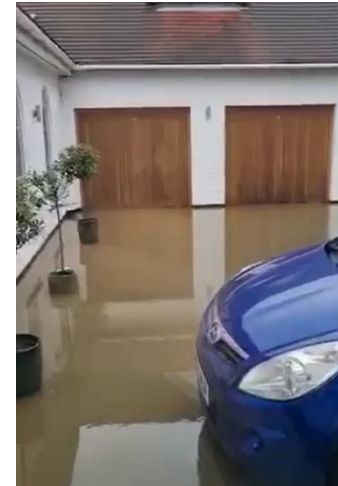
2. Flooding of driveway on 31 March 2023

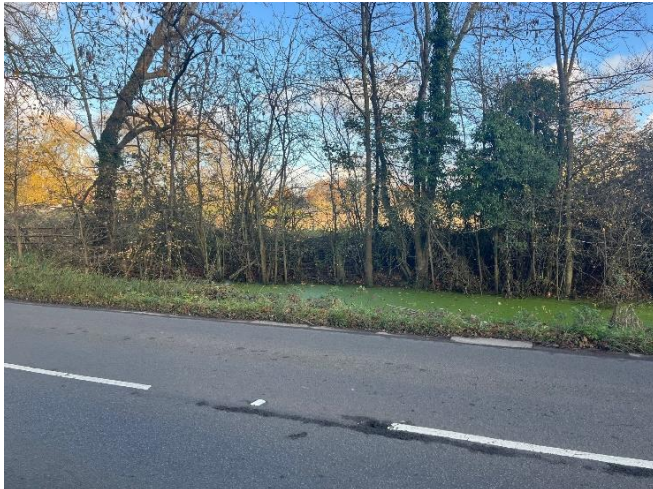
3. Site visit - high water levels in ditch on east side of the property (taken on 28 November 2023)

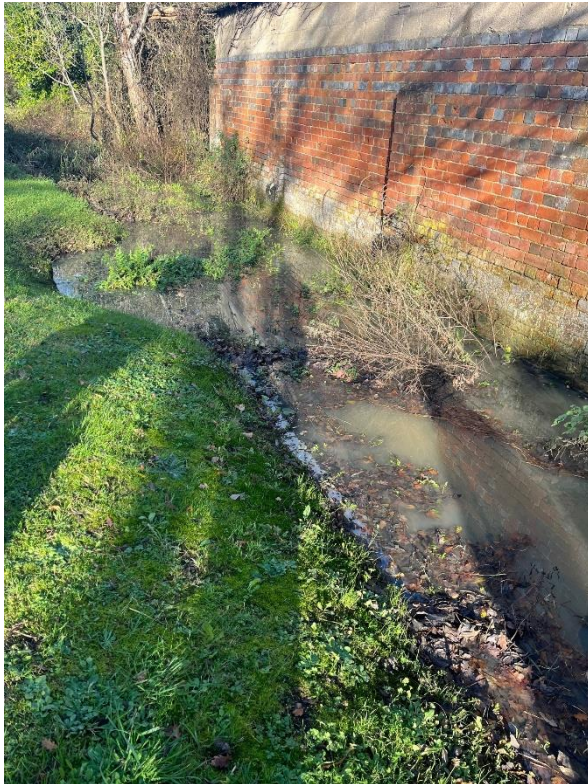
4b. Site visit - ditch downstream from culvert (taken on 28 November 2023)

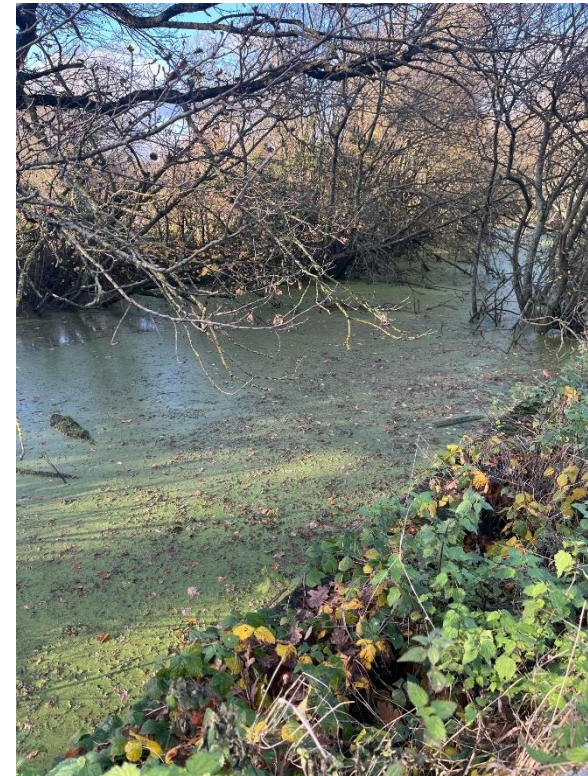
5. Site visit – ditch on western side of Wokingham Road, north of the property (taken on 28 November 2023)

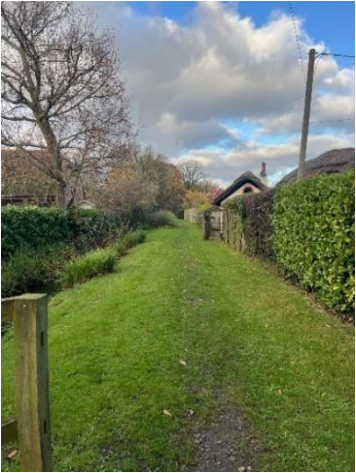
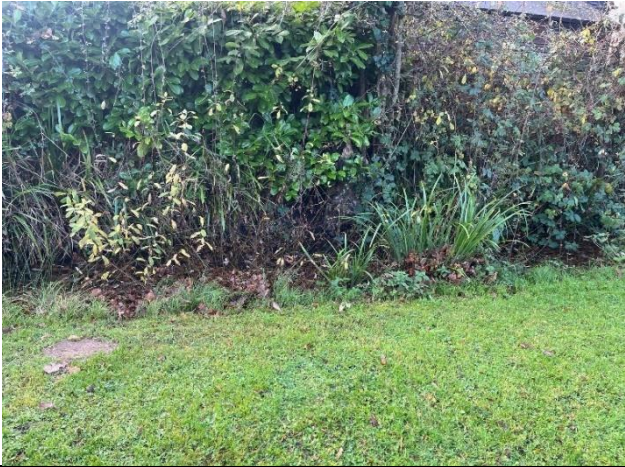
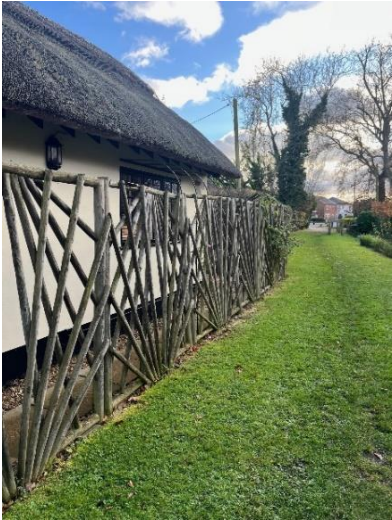
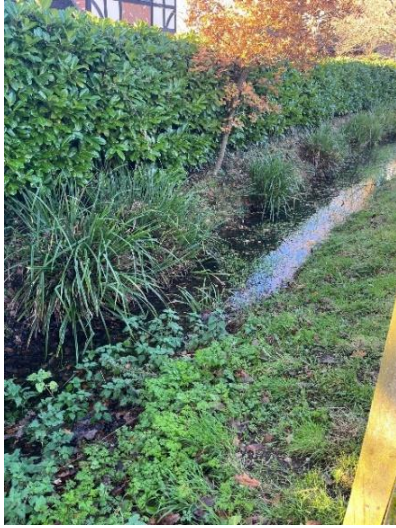
| <p>1. Footpath and ditch from the south of the property</p> | <p>2. Ditch on the western side of the property</p> |
| <p>3. Western side of property, adjacent to the footpath and ditch</p> | <p>4. Ditch on the western side of the property</p> |

Figure 8-6: Photographs of the property and surrounding ditch taken on 28 November 2023

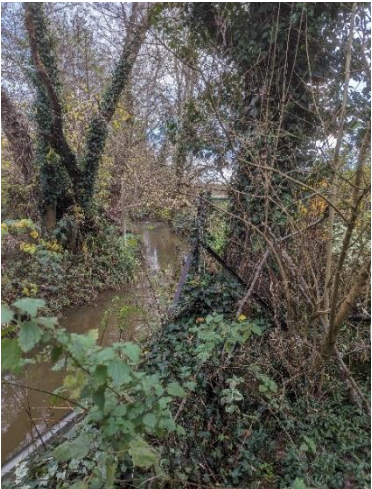
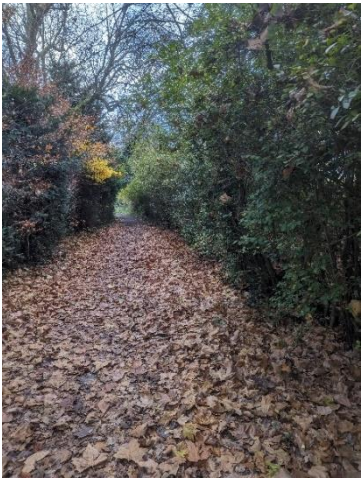
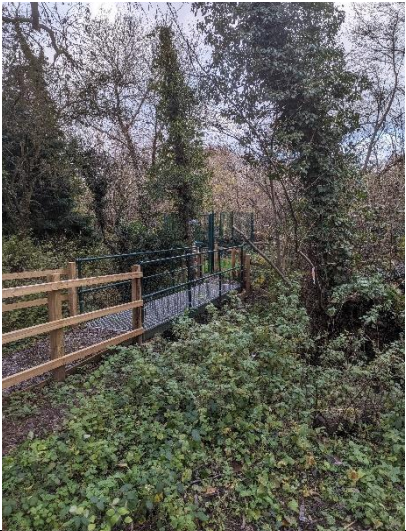
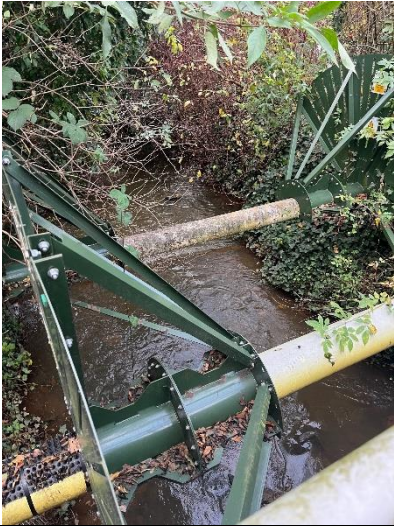
| <p>1. The Emm Brook River flowing eastward alongside the property</p> | <p>2. Footpath with a shallow ditch southwest of the property</p> |
| <p>3. River level gauge station located southeast of the property</p> | <p>4. The Emm Brook river from the bridge on Finchampstead Road</p> |

Figure 8-8: Photographs of the property in Wokingham and surrounding area taken on 28 November 2023

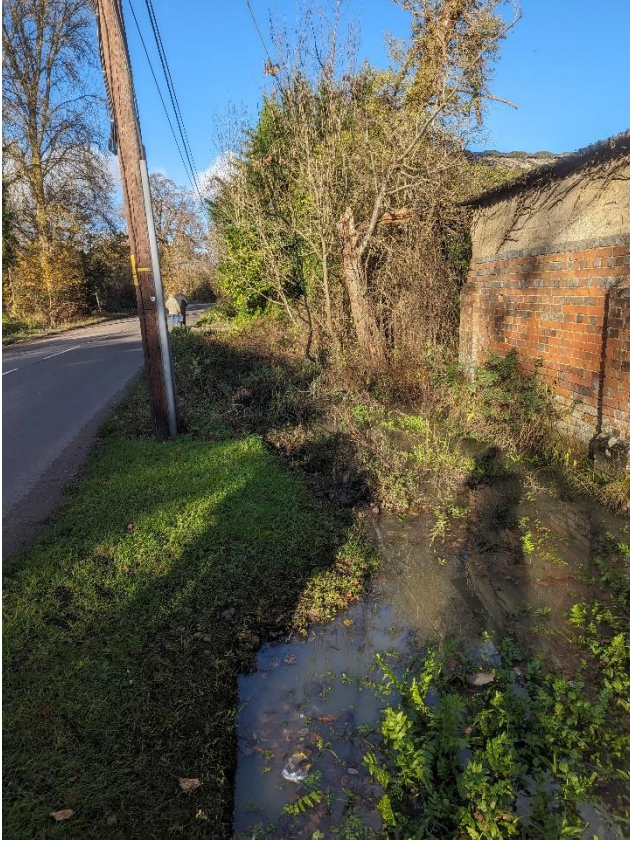
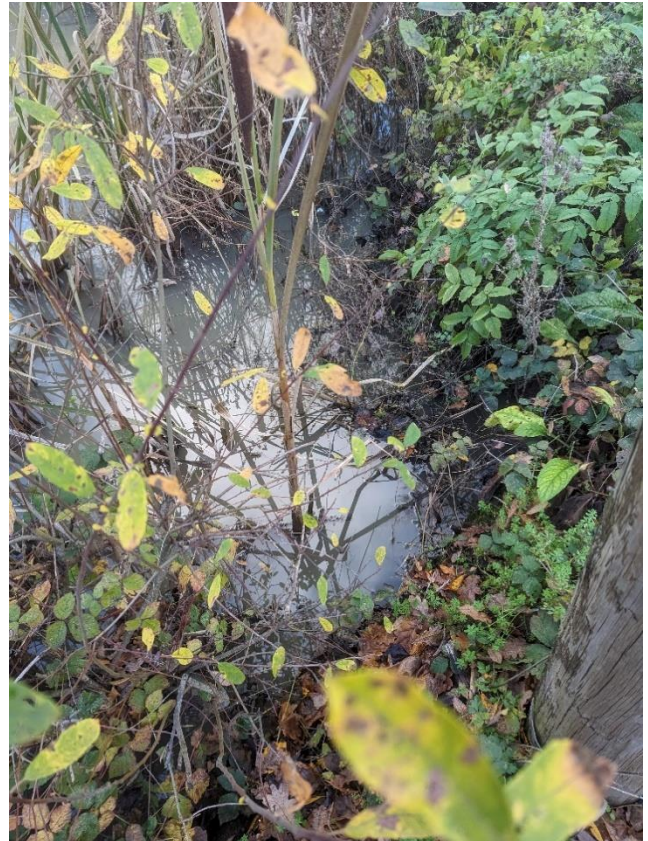
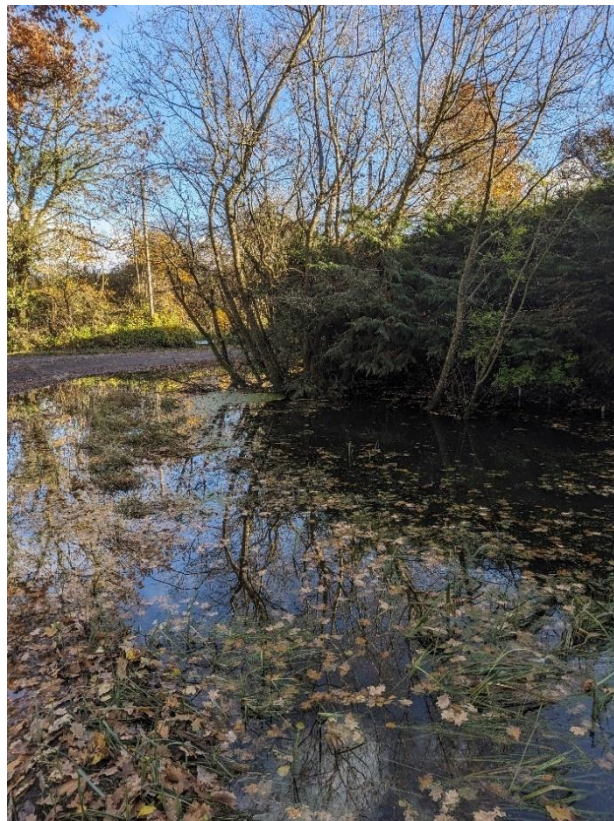
This is the most important recommendation detailed in this section, as the flooding experienced in Hurst Parish on 31 March 2023 was strongly linked to a lack of capacity along main river and ordinary watercourse systems, due to the presence of debris or heavy vegetation growth, as shown in Figure 9- 1. Therefore, taking preventative measures towards managing vegetation and debris along the watercourses is a key priority, to prevent a similar event happening in the future. It is important to note that channel maintenance is carried out sympathetically in relation to the ecology and habitat, to protect the species that live in and use the watercourses. It is also important ensure that any channel maintenance carried out works with natural processes and not against them.

Figure 9-2: Photographs showing presence of vegetation growth in watercourses in Hurst Parish

It is recommended that Wokingham Borough Council as LLFA, identify riparian owners in Hurst Parish and advise of riparian responsibilities. The Environment Agency, in partnership with the riparian owners, should consider an enhanced maintenance schedule for the extensive watercourse systems within the parish.

It is recommended that WBC as LLFA work in partnership with the EA and local residents to develop a riparian maintenance plan and ensure that riparian awareness is acknowledged and understood.

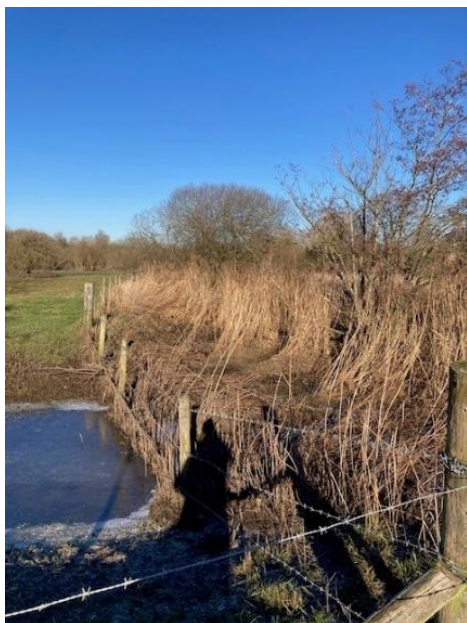
Twyford Brook severely restricted (January 2024)

One of the suggestions of the report prepared by landowners is the importance of maintaining flow in the Twyford Brook. The report recommends that all obstructions within the Twyford Brook, especially from the A321 (Hurst Road) bridge to Twyford station, to prevent water backing up towards Hurst Parish should be cleared. This Section 19 reiterates the importance of this as the Twyford Brook will play a key role in allowing flows from watercourses upstream to be discharged.

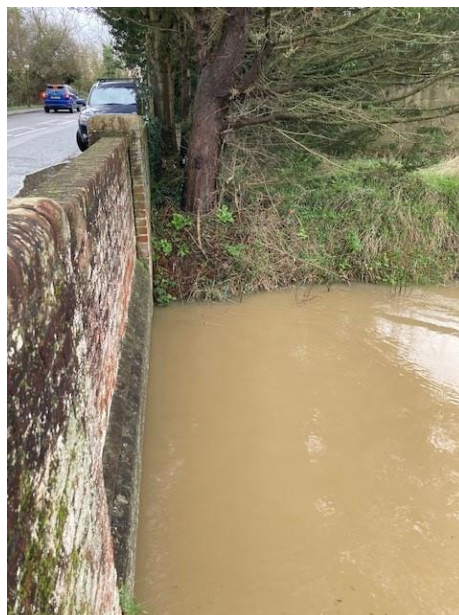
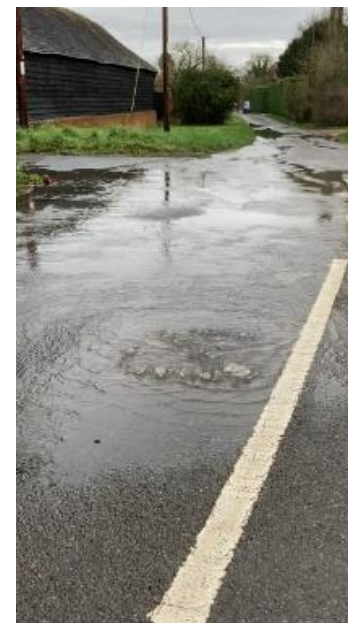
4. **Thames Water:** It is widely recognised that Thames Water's pumping station is woefully inadequate for the job, resulting in drains overflowing and adding to the flooding issues in Hurst. Therefore, WBC should deal with Thames Water to find a resolution for this problem.

Thames Water pumping station ineffective
